# Centreville Dam Removal Project

## Site Characterization Report

November 5, 2012

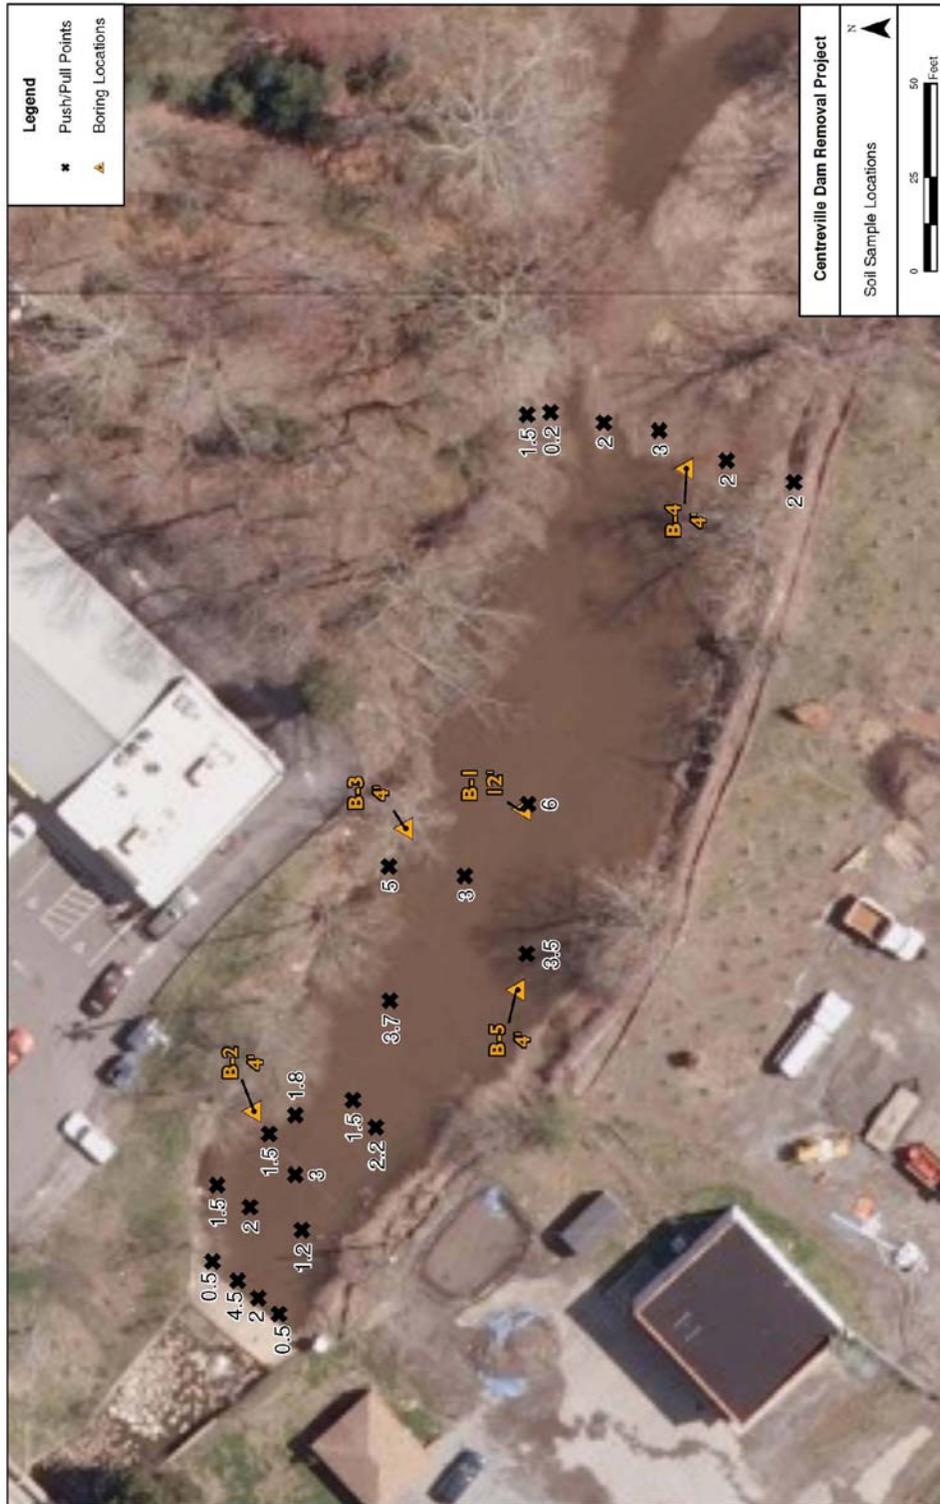
Figure 3. Boring Locations

In order to determine the nature of the subsurface conditions at the site, five borings were performed by John D. Hynes and Associates on June 7, 2012 within the impoundment. Locations of the borings are shown in *Figure 3*. Boring B-1 was drilled to the depth of 12 feet with the use of a tripod drill assembly by driving drill casing and using chopping and jetting techniques to clear the inside of the casing. Borings B-2 to B-5 were completed with the use of hand auger equipment to a depth of 4 feet. Samples were collected at each soil type encountered. The ground surface is considered to be the mudline of Gravel Run and water depths were between 1 to 2 feet deep at the boring locations. Samples of subsurface samples were examined and visually classified in accordance with Unified Soil Classification System (USCS) and ASTM Specification D-2488.

Boring B-1, located within the central portion of the impoundment, was completed to a depth of 12 feet. The boring yielded four feet of silt at the surface transitioning towards sand with some silt to ten feet. At this depth, a transition was observed to greenish brown silt with some fine to medium sand and some clay (**Table 4.5**).

Borings B-2 to B-5 were completed to a shallower depth of 4 feet. These borings consistently contained dark brown to brown silt with small amounts of sand and few organics. Boring B-2 contained some clay at depths between two and four feet.
